**NORWEGIAN  
TUNNELLING SOCIETY**

**Publication no. 29**

# **Tunnelling in the Follo Line project**

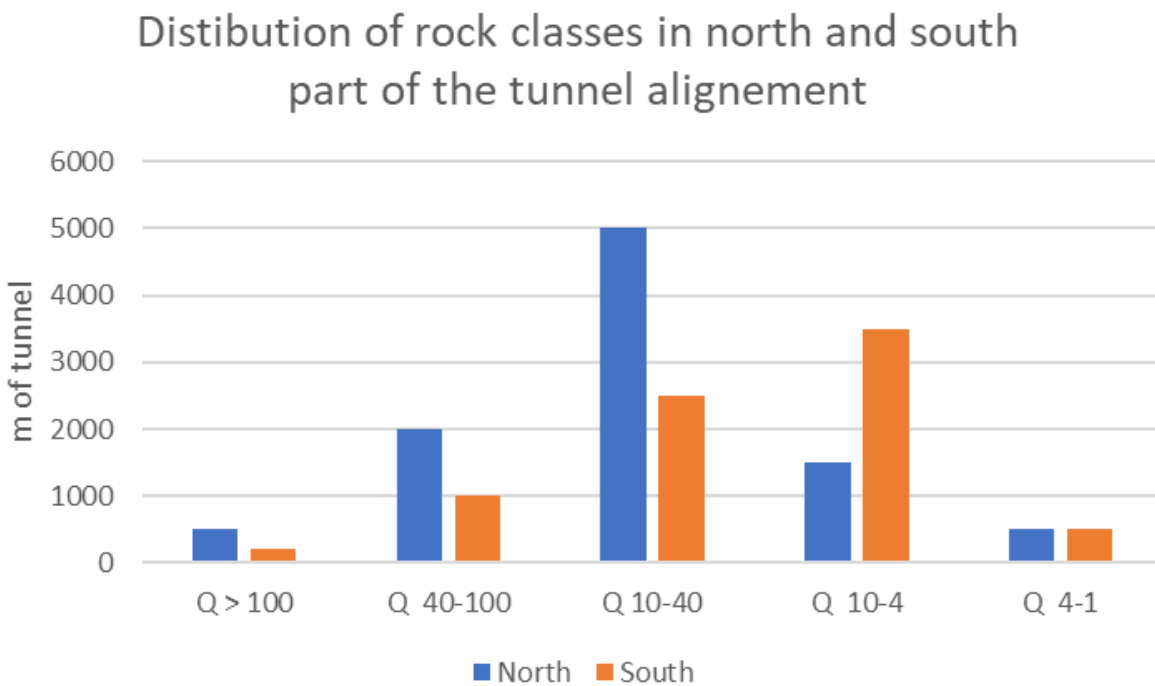
Figure 3-10: Distribution of rock mass classes from the Q TBM field mapping.

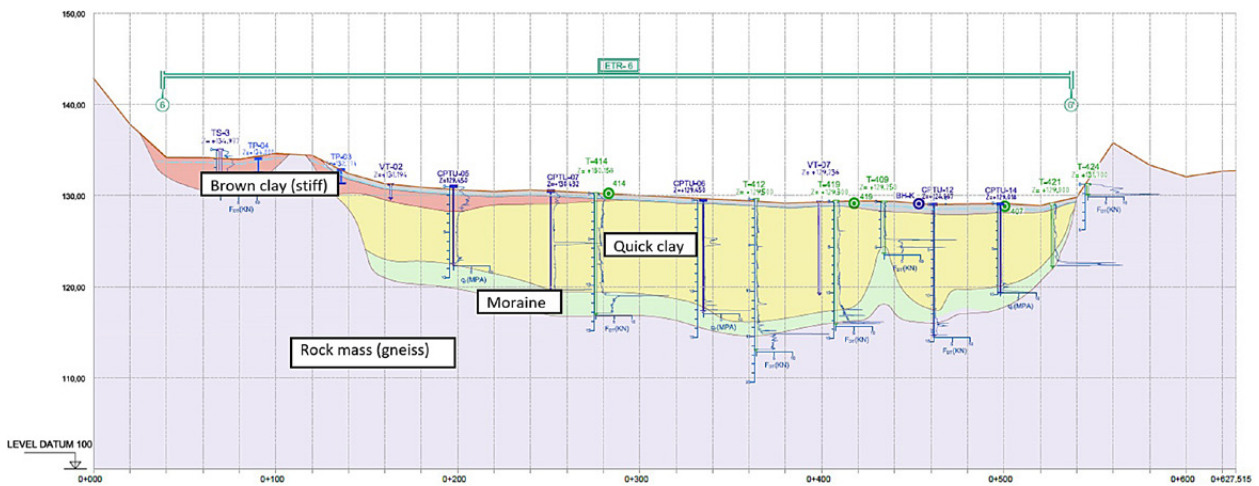
Figure 9-5: Geological profile along deposit area.

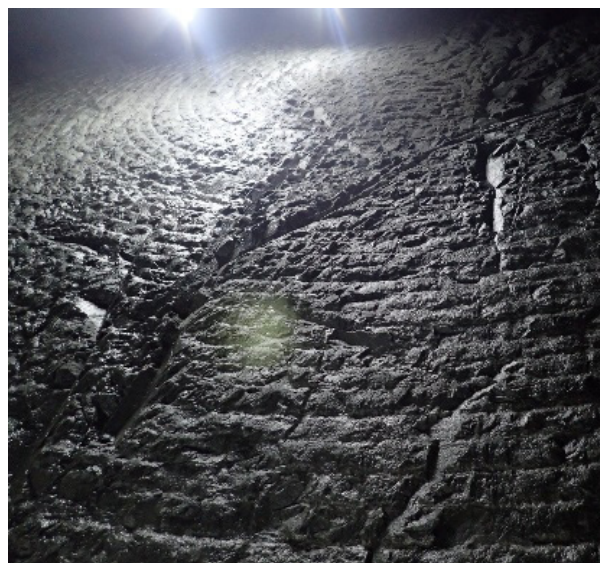
Figure 14-5: Fractures with different orientation identified at the face.

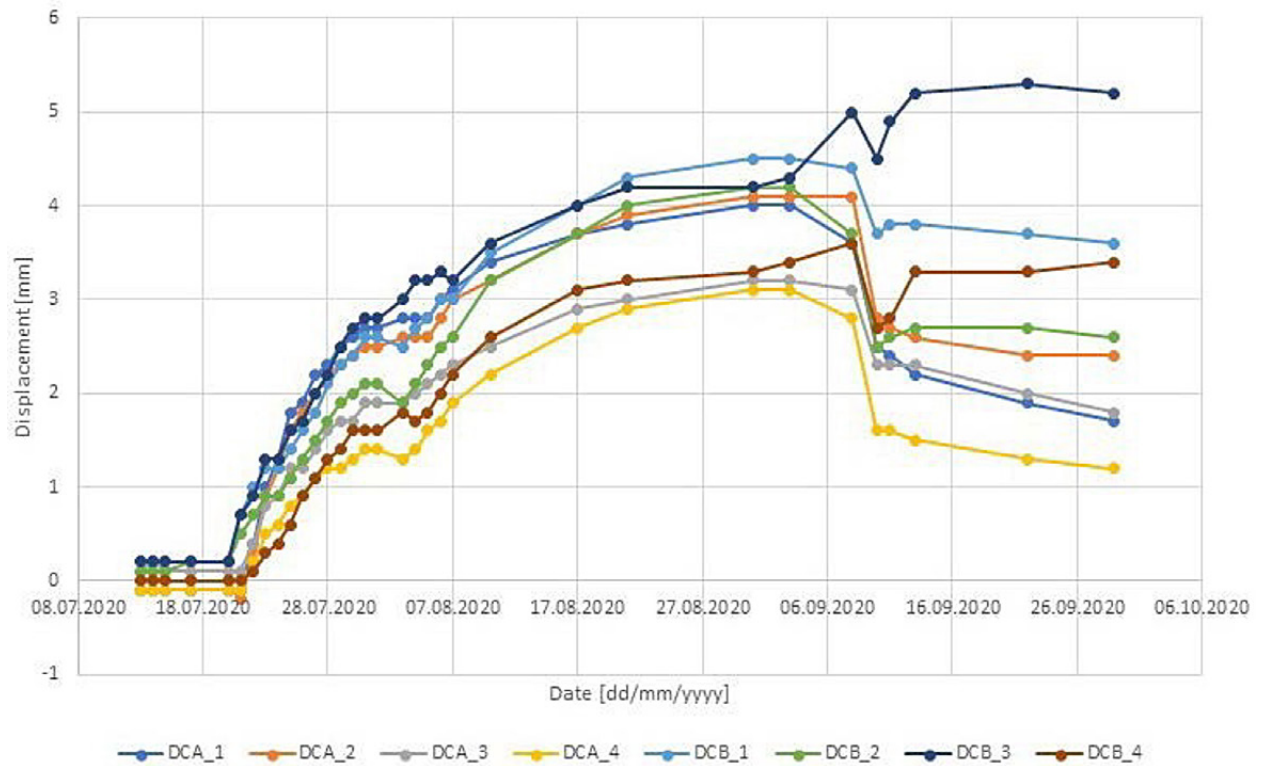
Figure 17-12: Measured displacements of the concrete lining during the period of the freezing of the model.

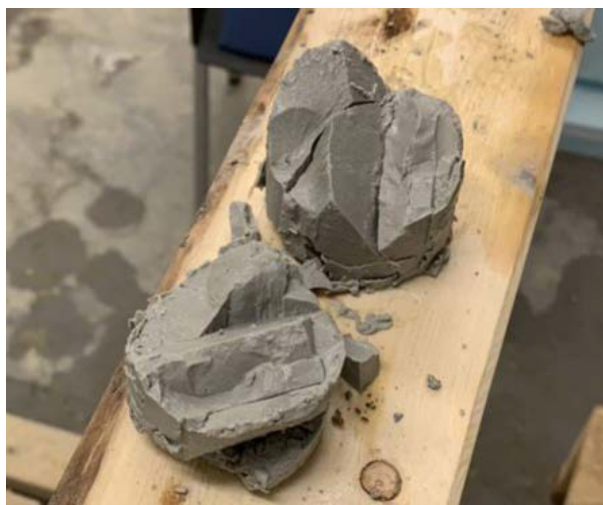
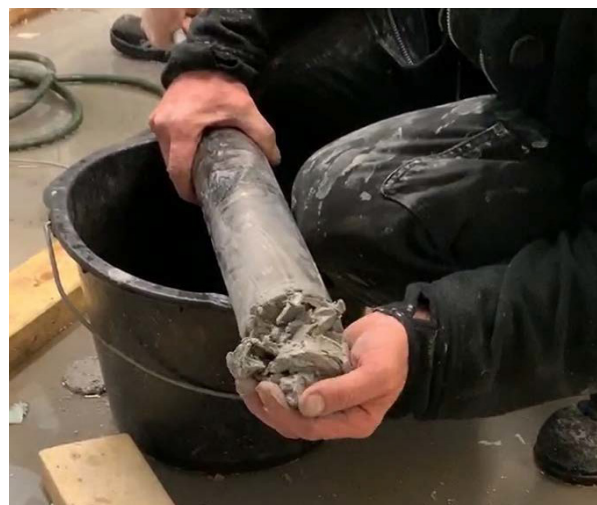
Figure 17-13: Left: Core sample of backfill grout, taken from the top of model B. Right: Core sample of backfill grout, drilled perpendicular through the concrete of model B.

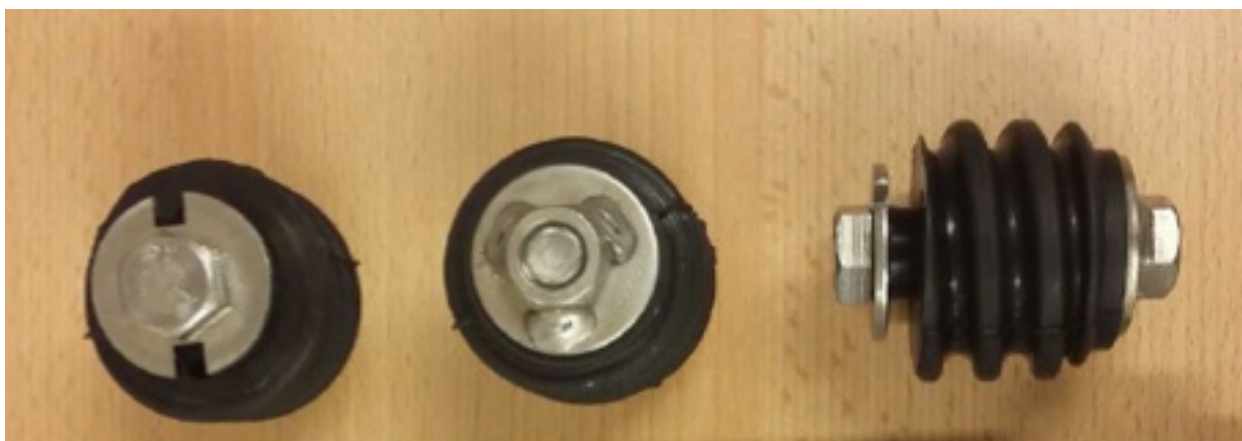
Figure 18-1: An EPDM mechanical packer.

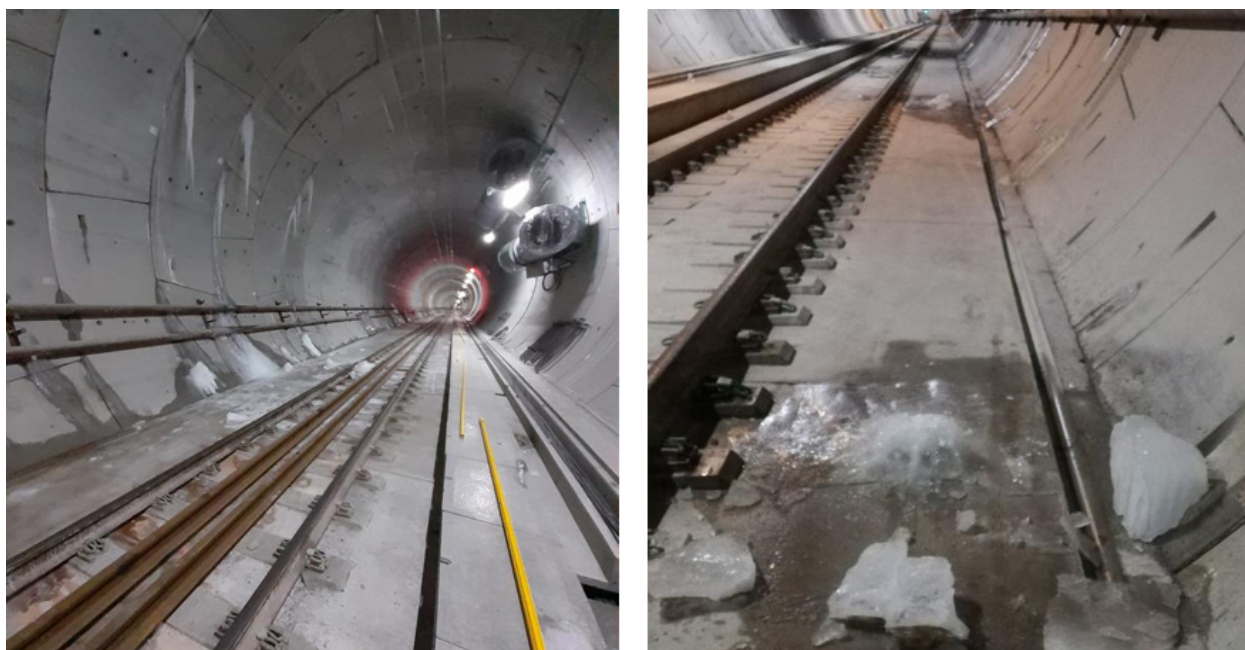
Figure 18-3: Ice formations in the tunnel.

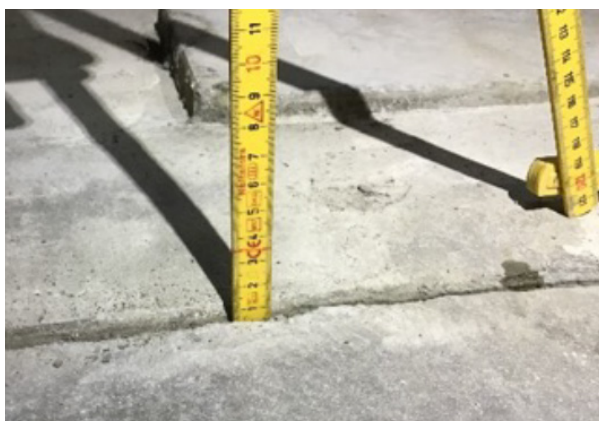
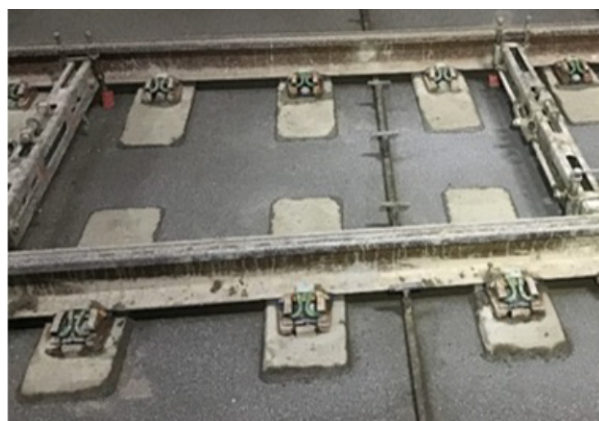
Figure 3: Left: Insufficient crack inducer. Right: Sufficient crack inducer.
